**Flood Control Project Maintenance
Levee Inspections**

Fall 2010 Levee Maintenance Deficiency Summary Report

Levee Inspection Report By Mile - Fall 2010

Sutter Maintenance Yard Wadsworth Canal

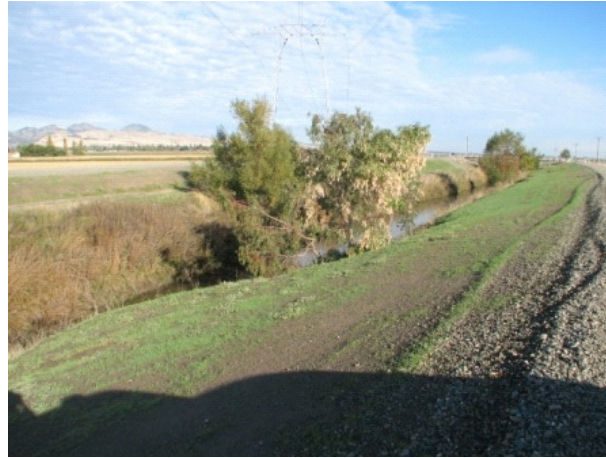
rduffey_f_20101109_262.jpg

Levee Mile Report Line	1
Start Levee Mile	3.18
End Levee Mile	3.25
Location	Water Side
Category	Earthen Levee
Item	Erosion / Bank Caving

View of the erosion at the waterside toe of the levee.

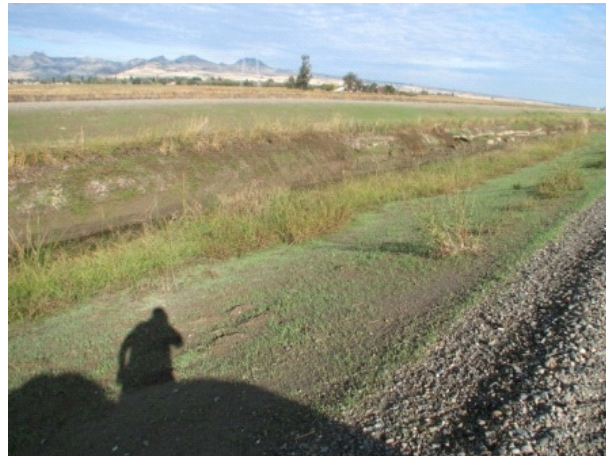
rduffey_f_20101109_263.jpg

Levee Mile Report Line	2
Start Levee Mile	3.56
End Levee Mile	3.59
Location	Water Side
Category	Earthen Levee
Item	Erosion / Bank Caving

View of the erosion along the waterside toe of the levee.

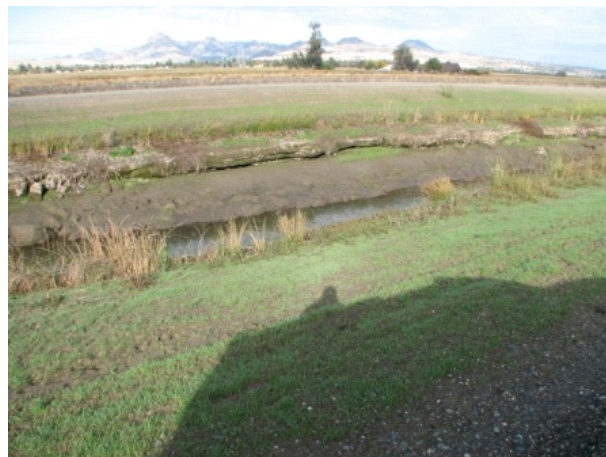
rduffey_f_20101109_264.jpg

Levee Mile Report Line	3
Start Levee Mile	3.68
End Levee Mile	3.68
Location	Water Side
Category	Earthen Levee
Item	Erosion / Bank Caving

View of the erosion along the waterside toe of the levee.

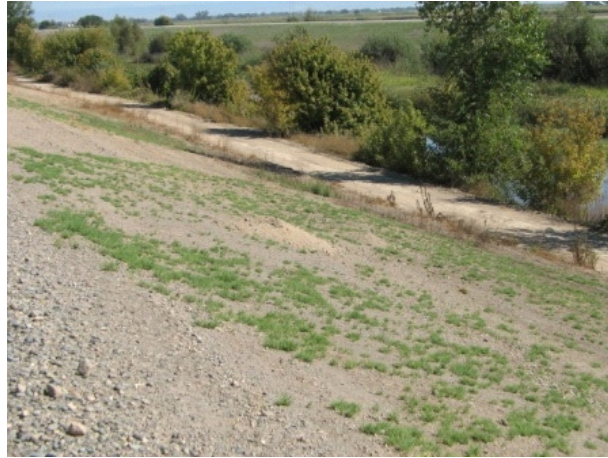
rduffey_f_20101101_236.jpg

Levee Mile Report Line	1
Start Levee Mile	0.07
End Levee Mile	0.07
Location	Water Side
Category	Earthen Levee
Item	Animal Control

View of squirrel hole along W/S.

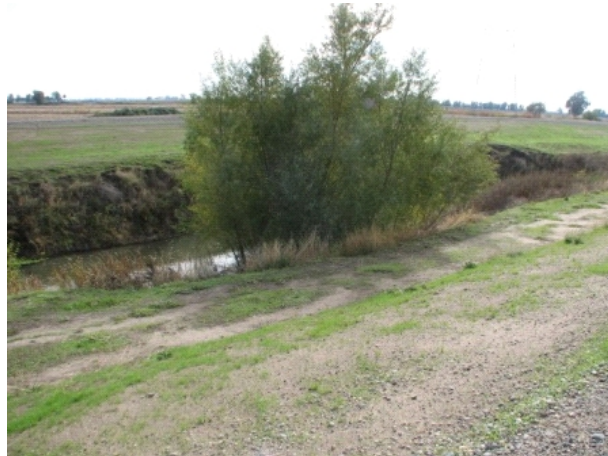
rduffey_f_20101109_253.jpg

Levee Mile Report Line	5
Start Levee Mile	3.21
End Levee Mile	3.21
Location	Water Side
Category	Earthen Levee
Item	Erosion / Bank Caving

View of the erosion at the waterside toe of the levee.

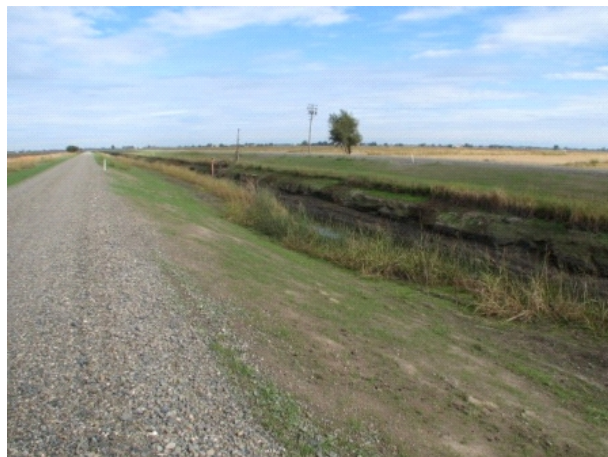
rduffey_f_20101109_252.jpg

Levee Mile Report Line	6
Start Levee Mile	3.46
End Levee Mile	3.46
Location	Water Side
Category	Earthen Levee
Item	Erosion / Bank Caving

View of the erosion at the waterside toe of the levee.

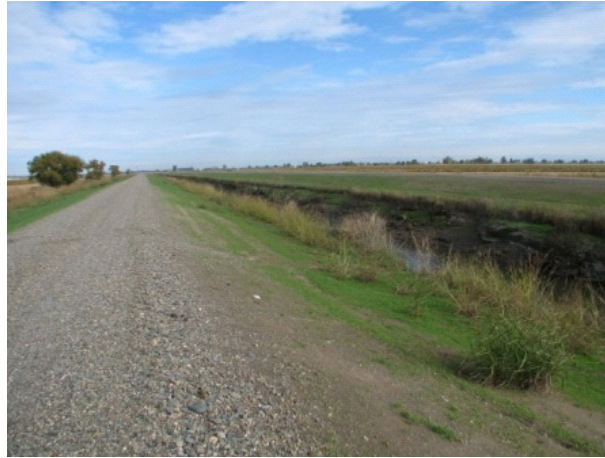
rduffey_f_20101109_254.jpg

Levee Mile Report Line	7
Start Levee Mile	3.59
End Levee Mile	3.99
Location	Water Side
Category	Earthen Levee
Item	Erosion / Bank Caving

View of the erosion along the waterside toe.

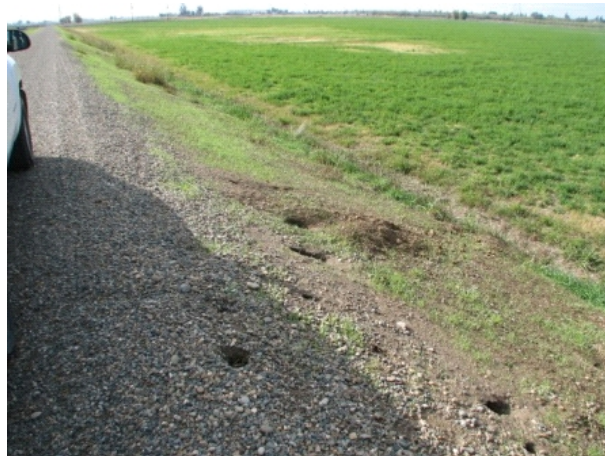
rduffey_f_20101109_251.jpg

Levee Mile Report Line	8
Start Levee Mile	4.61
End Levee Mile	4.61
Location	Land Side
Category	Earthen Levee
Item	Animal Control

View of squirrel holes along the slope.
